“A Technical Report on The Service Life of Ground Rod Electrodes”

July 7, 2003

ERICO, Inc.

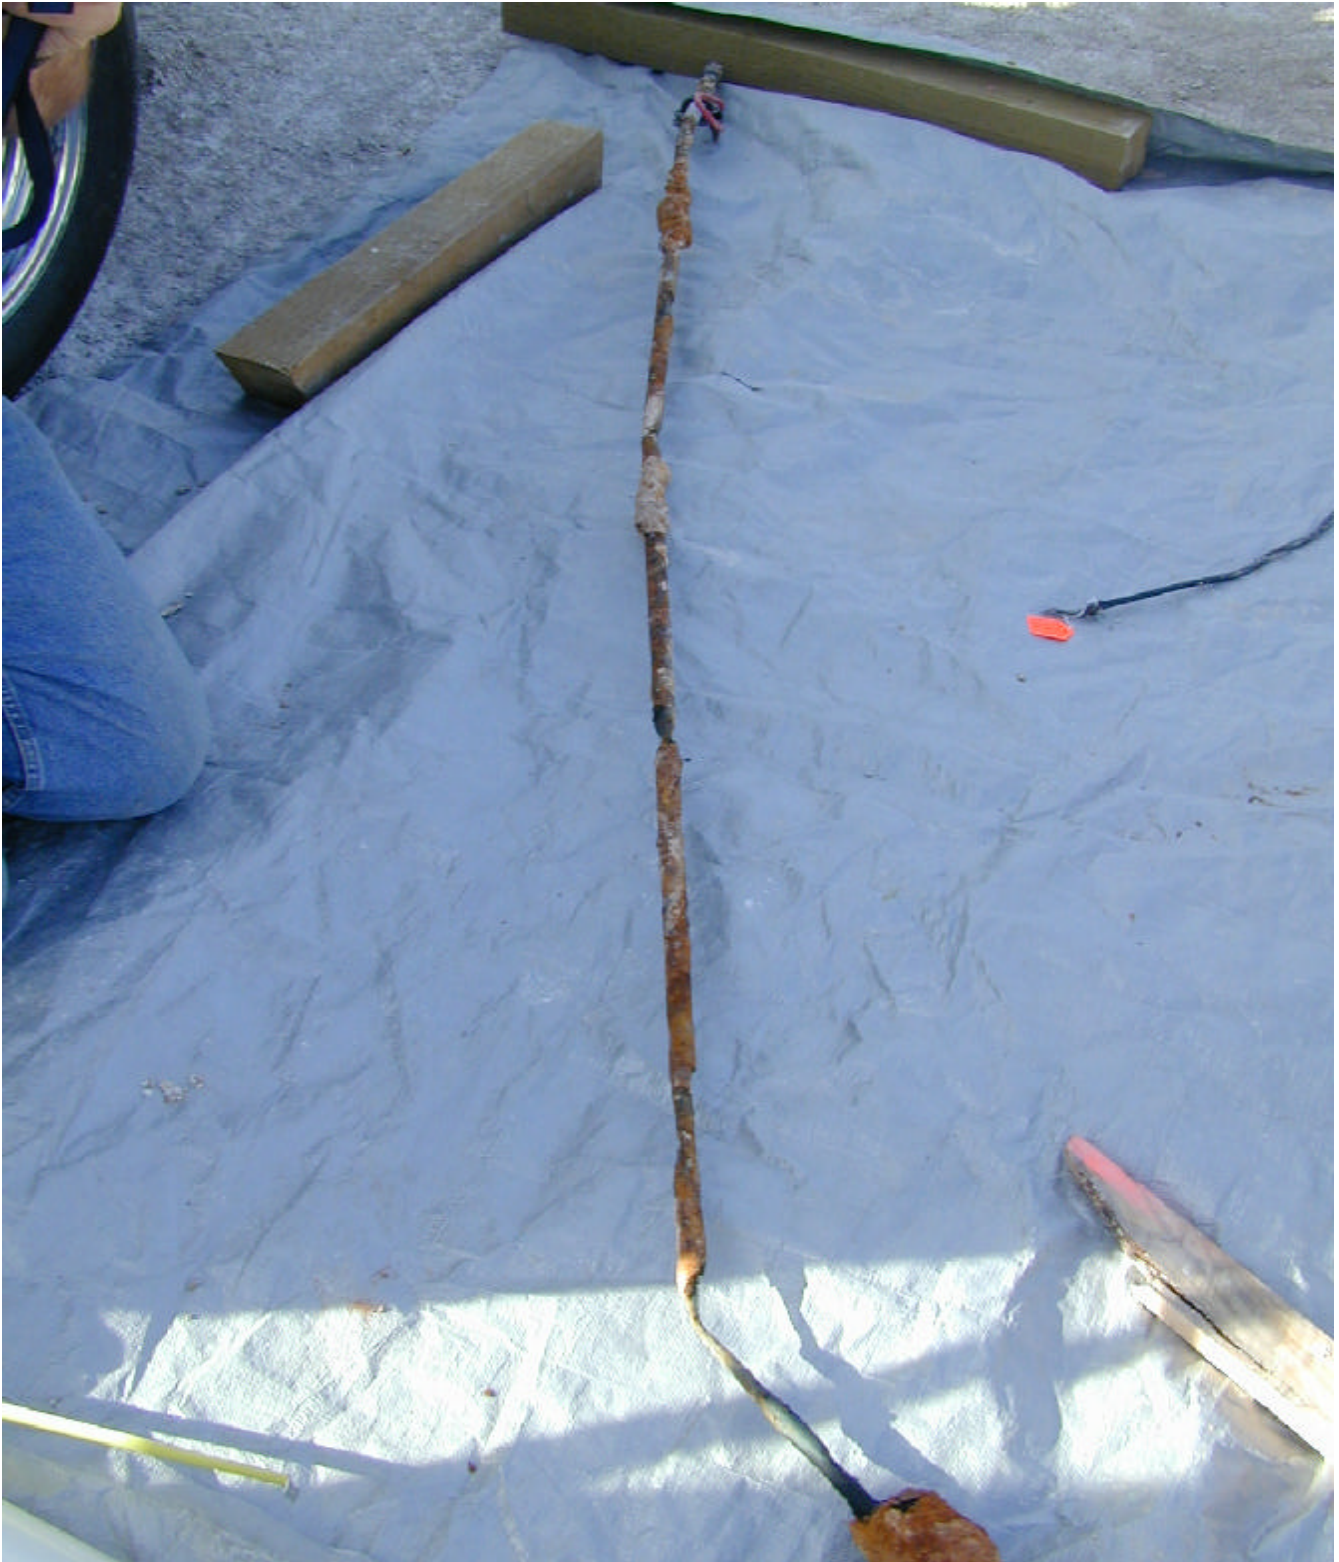
Figure 1. $\frac{3}{4}$ " x 10' galvanized rod removed after 10 years (Pawnee Site).

The NEGRP was started in 1992 to compare the long-term performance of different types of grounding electrodes. Originally organized by the Southern Nevada Chapter of the IAEEI, the study is now governed by the Fire Protection Research Foundation. In 2003, one of the original sites (Pawnee) was excavated and the rod electrodes removed. 5/8” copperbonded and 3/4” galvanized rod samples were exhumed. The results were definitive. The 5/8” copperbonded rod was virtually free of corrosion while the 3/4” galvanized rod showed significant deterioration (see pictures on next page).

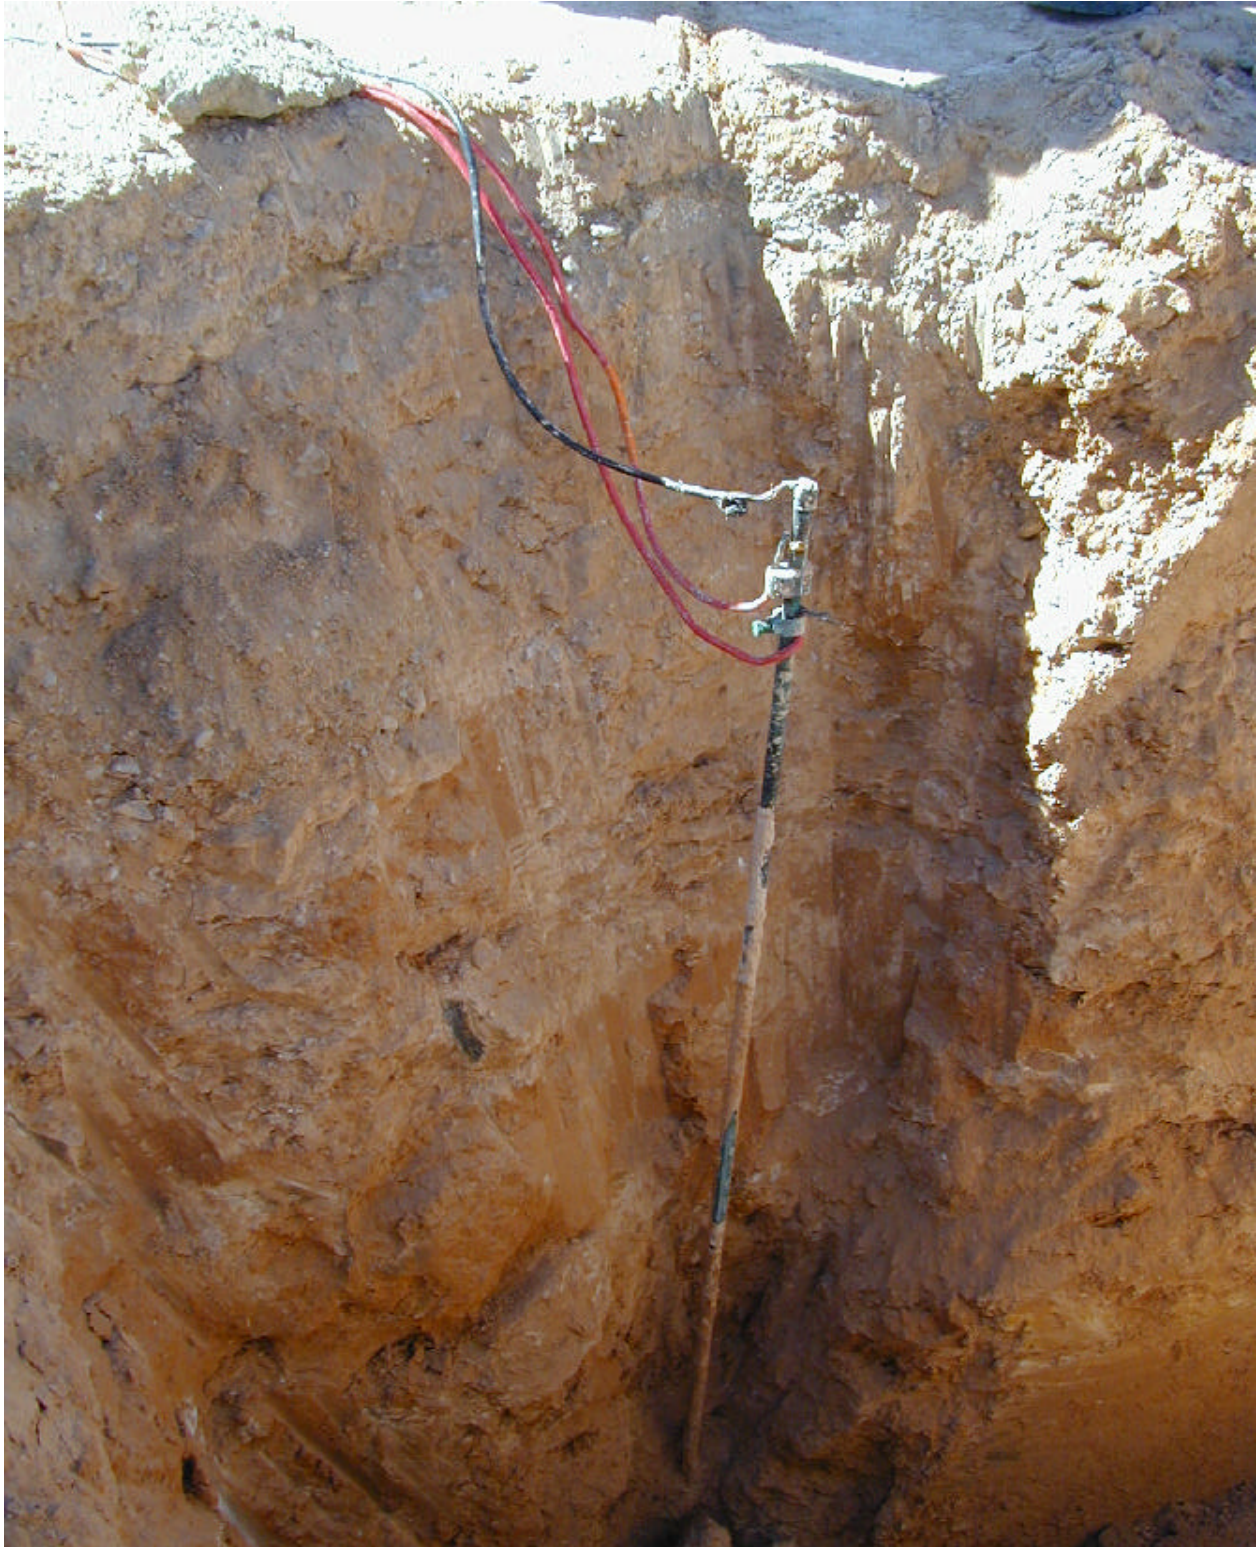
Figure 2. 5/8" x 8' copperbonded ground rod removed after 10 years (Pawnee Site).

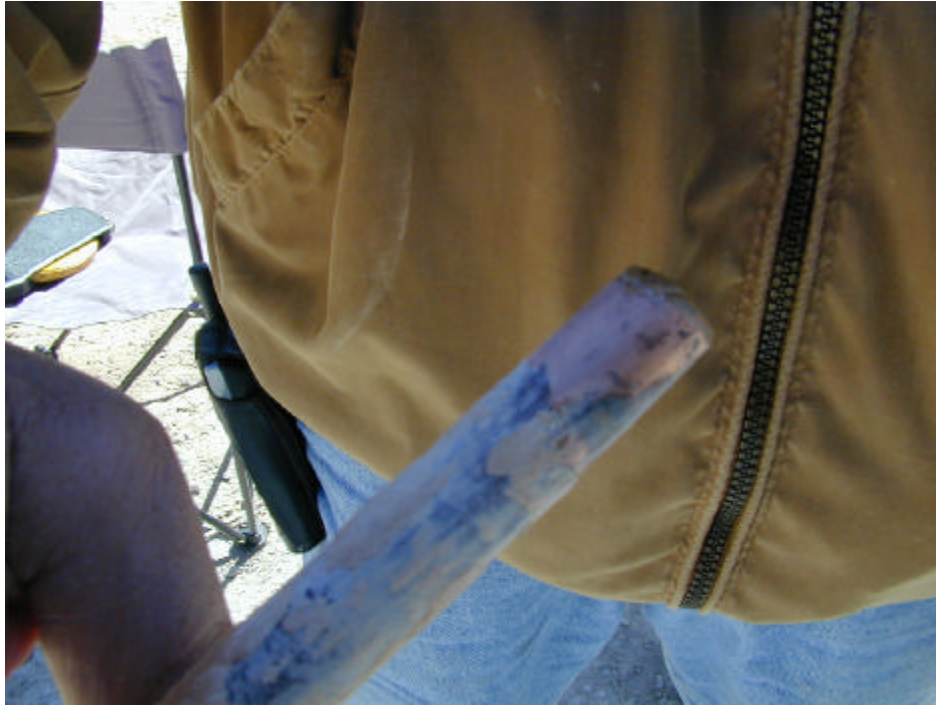
Figure 3. Close-up of 5/8" x 8' copperbonded rod after 10 years. Electrode type H.

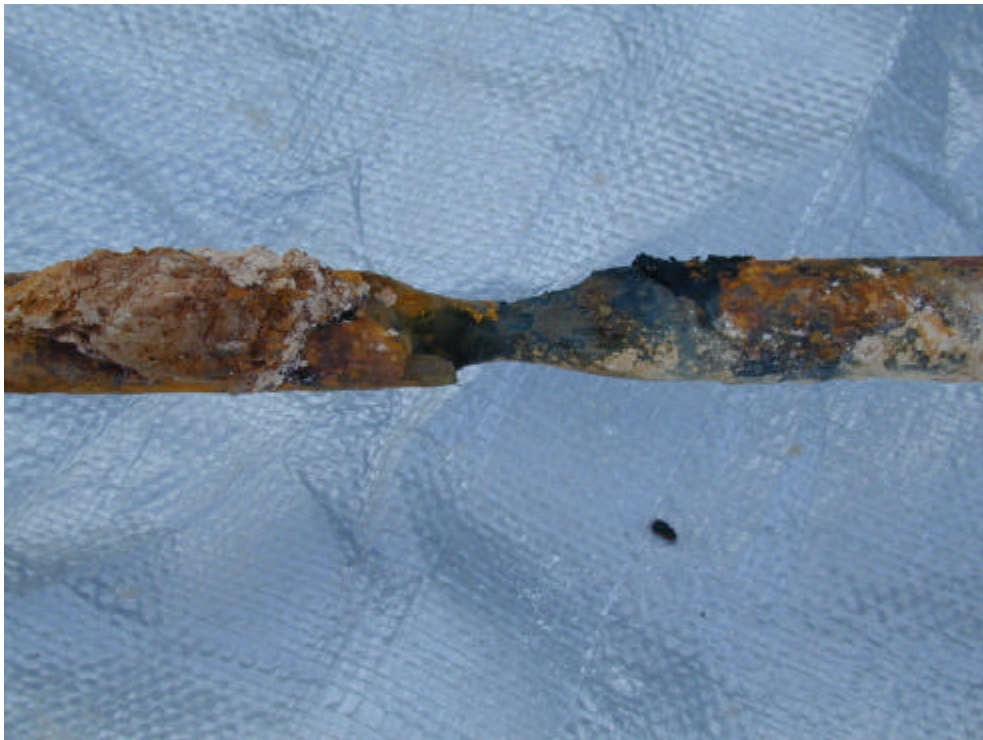
Figure 4. Close-up of 3/4" x 10' galvanized rod after 10 years. Electrode type I.
